# FIRE DOOR MAINTENANCE SCHEME

## Index of Accepted Repair Techniques

FIRE DOOR MAINTENANCE SCHEME	
Accepted Repair Techniques	
ART Number	01 Lipping Repair
Revision Number	10
Issue Date	01 January 2024
Expiry Date	31 December 2024

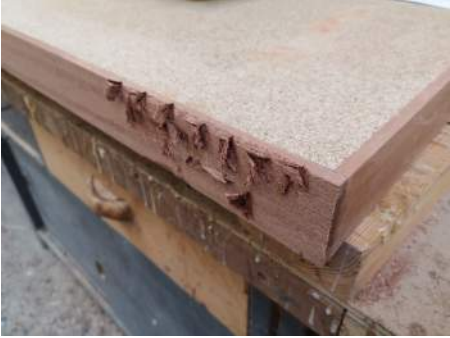
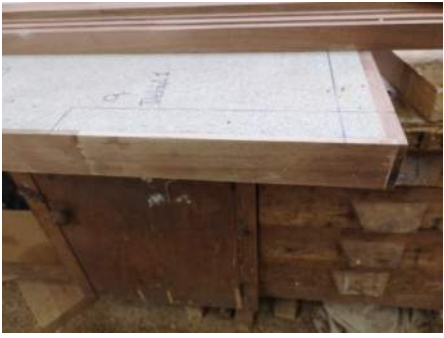
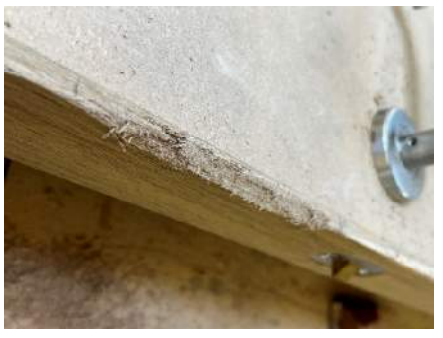
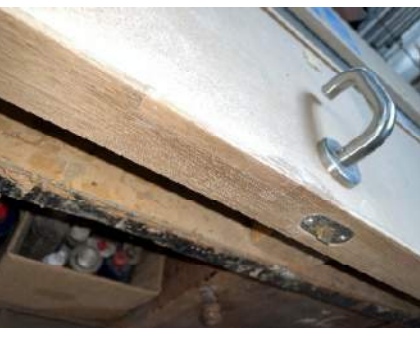
<b>Description of damage:</b> Damage to lippings.			
<b>Repair Technique Option 1:</b>			
If the lipping has splits and gouges where the timber has been broken away, the damaged area should be cleanly cut away by removing the relevant section of timber. If the damaged area is greater than 350mm in length, the entire lipping on that edge shall be replaced. A section of hardwood, minimum density of 640kg/m <sup>3</sup> equal in size to that removed, must then be tightly butt jointed in place. The new timber must be glued in position with a urea formaldehyde-based adhesive, or if evidence from the doorset manufacturer is available and supports its use, PVAc (Type D3) may be used. It is permitted to use pins to secure the newly applied section of lipping in place while the adhesive is setting. Pins must be left in place if applied. Residual gaps up to 1mm are to be filled with an epoxy wood filling product.

Exaggerated example of damaged section of lipping to full lipping width.	New section of full width lipping applied with voids filled with epoxy wood filling product.	Example of section (part width) of damaged lippings.	New section of lipping (part width) applied, and voids filled with epoxy wood filling product.

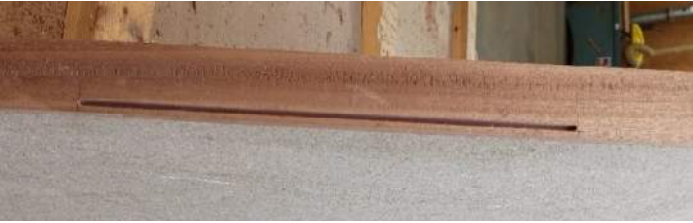
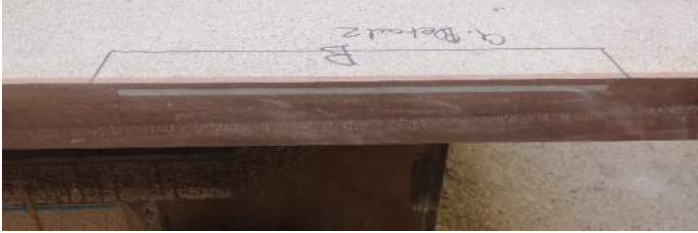
Repair Technique Option 2:	
<p>If the lipping has gouges to the wide face or edge of the lipping, measuring no greater than 5mm deep x 5mm wide x 350mm long, it is permitted to fill voids of these dimensions or less with an epoxy wood filling product. If the gouge coincides with the position of intumescent applied in the leaf edge, this option is not permitted and option 1 should be referred to.</p>

<p>Gouge in lipping, 5mm from leaf face, 5mm wide x 5mm deep x 350mm long</p>	<p>Gouge filled with epoxy wood filling product.</p>

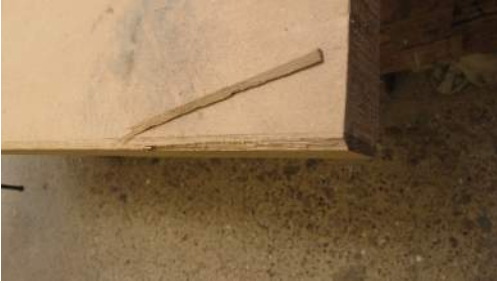
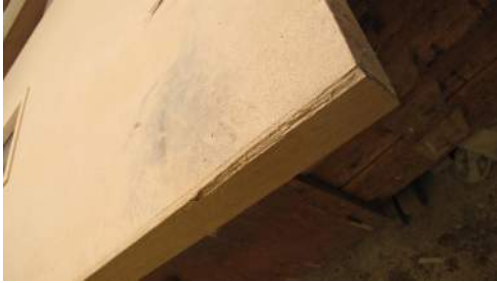
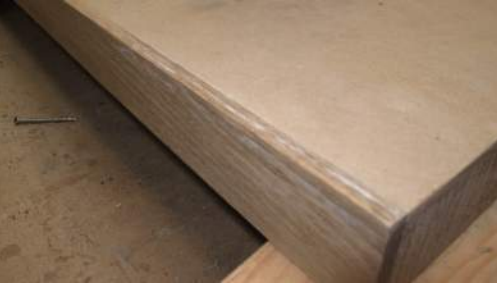
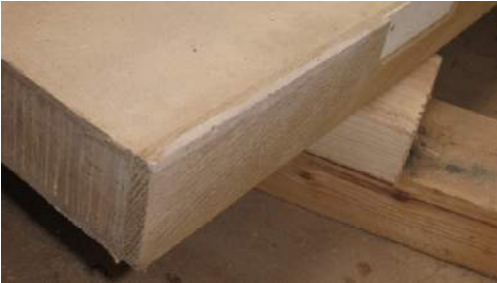
Repair Technique Option 3	
<p>If the lipping material has splintered resulting in a section pulling away from the leaf edge, providing the splintered section measures no greater than 5mm deep x 5mm wide x 350mm long, it is permitted to either adhere the section of timber back to the lipping with a urea formaldehyde-based adhesive or, if evidence from the doorset manufacturer is available and supports its use, PVAc (Type D3) may be used. Gaps which may be present up to 1mm at the edge of the adhered section, shall be filled with an epoxy wood filling product or it is permitted to remake the section completely with an epoxy wood filler to match the existing thickness of the lipping. Excess adhesive and epoxy wood filler shall be sanded flush to the face of the leaf.</p>

Example of splintered section of lipping, complete with splintered timber.	Example of splintered section of lipping, without splintered timber.

Example of splintered section of lipping with splintered section adhered back into position.	Example of remade section of lipping utilising an epoxy wood filling product.

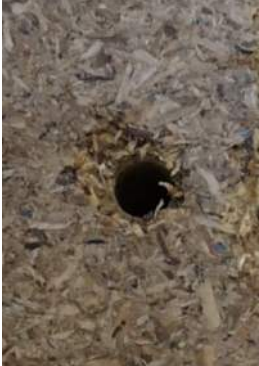
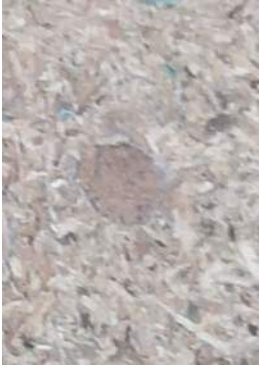
<p><b>Description of damage:</b> Over recessed hardware or hardware which has been removed leaving voids. This applies to doorsets which have had new items of hardware fitted (hinges, locks, closers, or flush bolts) and the voids left by the original hardware have not been filled.</p>	
<p><b>Repair Technique Option 1: (Existing Screw Fixing Holes)</b></p>	
<p>When a doorset includes voids left from existing screw fixings which do not penetrate the leaf thickness. Screw fixing holes matching the criteria above are required to be filled with a hardwood timber, of minimum density of 640kg/m<sup>3</sup>, secured with a urea formaldehyde-based adhesive and residual gaps are to be filled with epoxy wood filling product, sanded flush to the face of the leaf.</p>

<p>Voids left from previous screw fixings.</p>	<p>Voids left from previous screw fixings filled with timber &amp; epoxy wood filling product then sanded flush.</p>

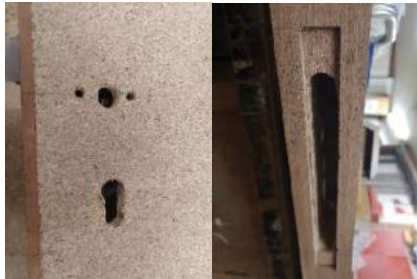
Void within leaf edge & frame following the removal of a lockset.

- The void must be made good by jointing a section of timber (30 minutes fire resistance – minimum density of 510kg/m<sup>3</sup> & 60 minutes fire resistance – minimum density of 640kg/m<sup>3</sup>).
- The void must be completely filled with timber and tightly butt jointed where multiple sections of timber are required.
- It may require the edges of rounded apertures being squared such that a timber section may be applied tightly within the void.
- In both cases (30 and 60 minutes fire resistance) the timber sections must be adhered in position utilising a urea formaldehyde-based adhesive.
- Residual gaps of up to 1mm are to be filled with an epoxy wood filling product.

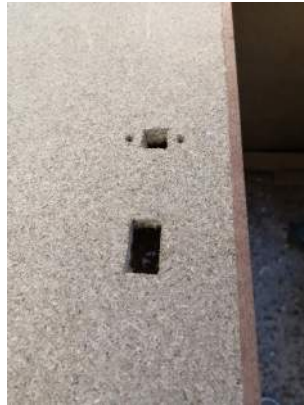
Edges of the void squared such that timber sections fully fill the area.

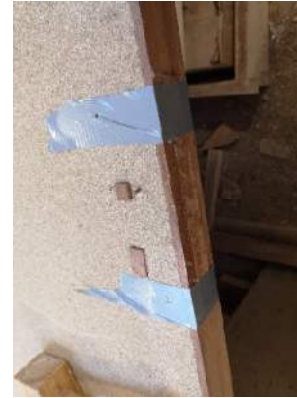
Timber sections applied to the leaf & frame.

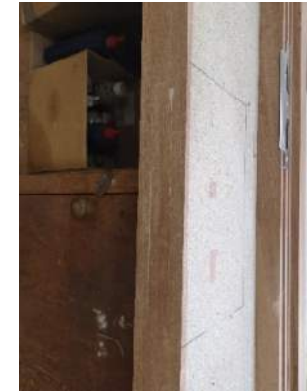
Epoxy wood filling product applied, filling gaps of up to 1mm.

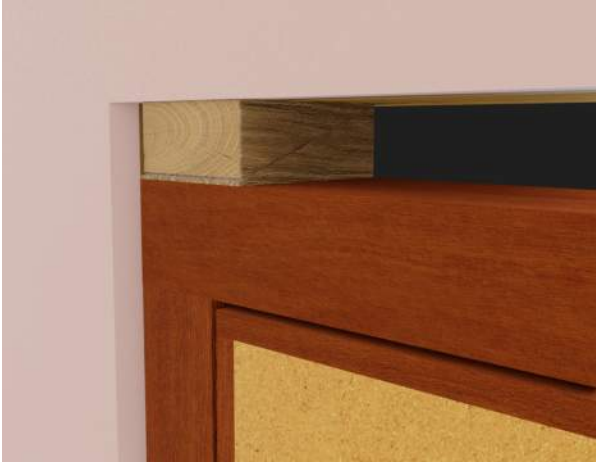
<b>Description of damage:</b> Door frame joints have separated, leaving gaps between the head and jambs.
<b>Repair Technique Option 1: (Door frame in situ)</b>
<p>Door frame joints that have separated leaving gaps between the head and jambs, may be repaired in the following way:</p> <ul style="list-style-type: none"> <li>○ Application of PVA adhesive within the joint local to the head and jambs.</li> <li>○ Utilising hardwood timber wedges, bring the two elements (head and jamb) together until the adhesive has cured bonding the two elements together.</li> <li>○ Apply additional screw fixings of appropriate length through the head of the frame fastening the head to the jamb. Due to limitations on access, these may be applied at an angle through the rear of the frame element.</li> <li>○ Excess adhesive is to be sanded flush to the door frame and applied wedges are to remain in position.</li> </ul>

Timber frame joint gaps post repair, with timber wedges in place.

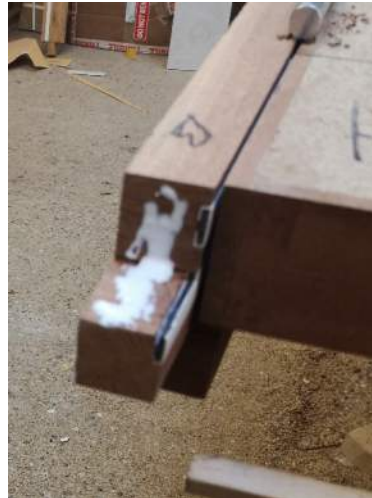
Application of PVAc (Type D3) adhesive to re-made joint within workshop conditions.

- Removal of the doorset.
- Remake the joint between the head and jambs using conventional joinery methods (e.g., re-making the existing jointing method), with PVAc (Type D3) applied within the joint.
- Apply appropriate mechanical fixings with sufficient length, to provide fixity to the re-made joint (steel wood screws).
- Reinstallation of the doorset in accordance with available supporting evidence, or if none is present, BS 8214:2016 for up to 60 minute applications only.

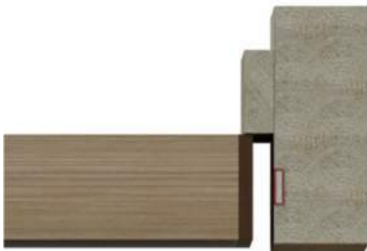
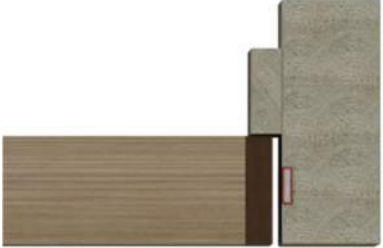
Repair Technique Option 2: (Application of thicker lipping to vertical or bottom leaf edges for timber doorset up to 60 minutes only).			
<p>If a door leaf is too small for the opening within the frame, it may be necessary to apply a thicker lipping to the leaf edge. Where applicable, this should be completed as follows:</p> <ul style="list-style-type: none"> <li>○ The existing lipping where the thicker lipping is required must be removed. This repair may be applied to vertical and bottom edges of the leaf simultaneously if required.</li> <li>○ The edge of the leaf must be made square. A maximum of 1mm is permitted to be removed from the leaf edge once the lipping has been removed in order to achieve this.</li> <li>○ The new lipping with the appropriate thickness and a density of no less than 640kg/m<sup>3</sup>, excluding Beech (Fagus Species), and no more than 5mm thicker than the original lipping thickness, is to be glued in position using a urea formaldehyde-based adhesive.</li> <li>○ All intumescent / smoke seals, hardware and associated intumescent protection must be refitted.</li> </ul> <p>If the leaf you are looking to apply a lipping to, does not have an existing lipping, it is <b>not</b> permitted to apply a lipping to the edge of the leaf.</p>

Door leaf within frame – Incorrect gaps.	Door leaf with lipping removed.	Door leaf with thicker lipping applied.	Door leaf within frame – Correct gaps.

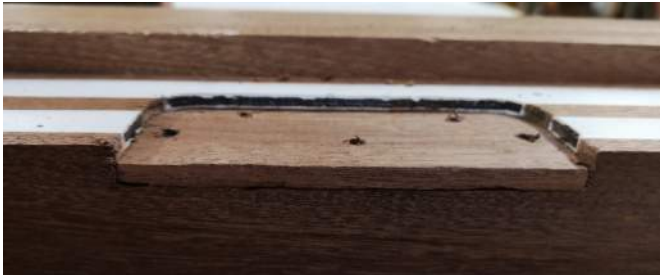
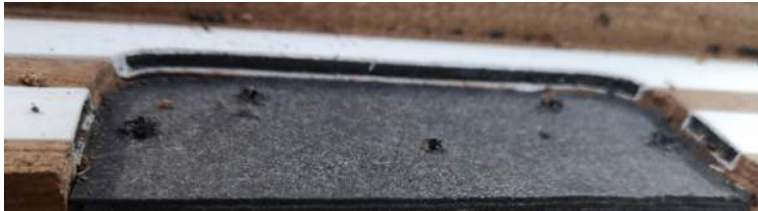
Repair Technique Option 3: (Modification to the packing material behind hinge blades for timber doorset up to 60 minutes only).	
<p>It may be possible to adjust the door gaps by modifying the material behind the hinge blades, if the hinge blade is rebated but the face of the hinge blade is no longer flush with the frame reveal or leaf edge. In all instances it is not permitted to remove intumescent protection which is applied behind the hinge blades i.e., if the hinge already has intumescent material applied this must not be removed.</p> <p>Additional material may be applied behind the hinge blade to the door frame to adjust the leaf to frame gaps in the following forms:</p> <ul style="list-style-type: none"> <li>○ A single hardwood timber shim, suited to the rebate of the hinge blade with a thickness between 1-5mm and a density of 640kg/m<sup>3</sup>.</li> <li>○ Up to 2no. layers of 1mm thick intumescent sheet matching the existing specification or material.</li> <li>○ The above items which may be applied behind the hinge blade to the frame may be used in conjunction with each other. When applied, the hardwood timber shim must be seated at the base of the rebate and the intumescent material must be applied between the shim and the hinge blade.</li> </ul>

<p>Hardwood timber shim applied behind the hinge blade on the frame.</p>	<p>2No. layers of 1mm thick graphite type intumescent sheet applied behind the hinge blade on the frame</p>

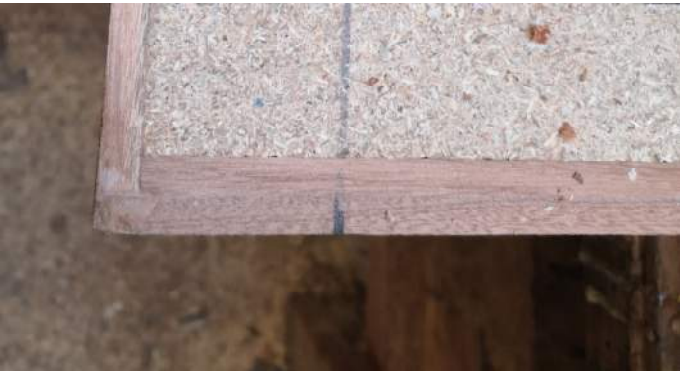
Repair Technique Option 4: (Application of additional lipping material to the bottom edge of the leaf for 30 minutes timber doorsets only)
<p>Where the door gap at the bottom of the leaf is outside the tolerance permitted by the supporting evidence for the doorset design, or in the case that there is no evidence available in support of the doorset design and the gaps are outside of the range highlighted within BS 8214: 2016, the gaps require alteration. It is permitted to apply an additional timber lipping of up to equal thickness of the current lipping applied to the bottom edge of the leaf, to the following specification:</p> <ul style="list-style-type: none"> <li>○ The lipping must consist of hardwood timber with a minimum density of 640kg/m<sup>3</sup>.</li> <li>○ The lipping must be adhered with a urea formaldehyde-based adhesive and must be pinned in position at no less than 300mm centres, 100mm from each leaf edge. Pins are to be positioned centrally within the thickness of the lipping and to remain in position once the adhesive has cured.</li> <li>○ The lipping may be up to equal thickness of the lipping applied to the bottom edge of the door leaf.</li> </ul> <p><b>This Repair Option is Only Permitted for 30 Minutes Fire Resistance Performance.</b></p>

<p>Door leaf with additional lipping applied.</p>

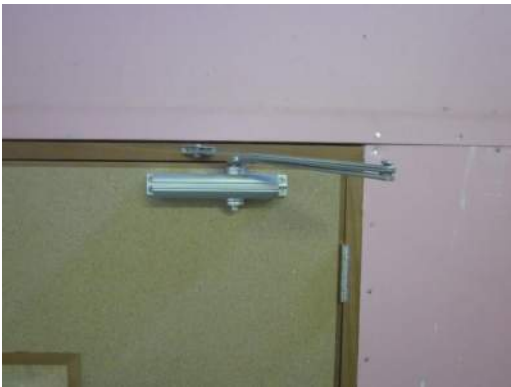
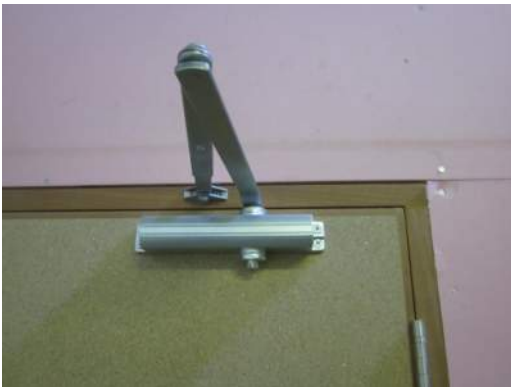
Repair Technique Option 2: (Closer adjustment)	
<p>Where a doorset is failing to achieve self-closing, a check should be undertaken to identify the following:</p> <ul style="list-style-type: none"> <li>○ Check if the door leaf is binding with the frame.</li> <li>○ Check for obstruction to the door leaf operation.</li> </ul> <p>If there are no visible signs of the above, the door closer should be checked for its suitability for the application or if it has mechanically failed.</p> <p>If the door closer has not mechanically failed and is suitably sized for the application, the door closer shall be adjusted. The maintainer shall observe the regulatory requirements for a door closer including those outlined within Approved Document M and ensure they are complied with.</p> <p>Where the adjustment method for the closer is indicated on the device care should be taken to adjust the door to close appropriately. If there is any doubt as to how to adjust the closer, advice from the closer manufacturer should be sought in the form of written instructions. If the closer still cannot be adjusted to meet the closing requirements of the doorset then refer to Repair Technique Option 1.</p> <p>If it is not possible to achieve self-closing as well as maintain the regulatory requirements, other factors may need to be considered, for example, excessive air flow into the room may be preventing the door from closing.</p>

<p>Example of a self-closing device which is incorrectly set up.</p>	<p>Example of a self-closing device adjusted in accordance with the manufacturer's instructions.</p>

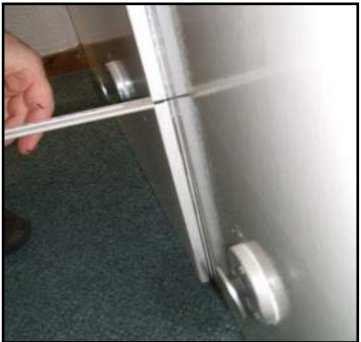
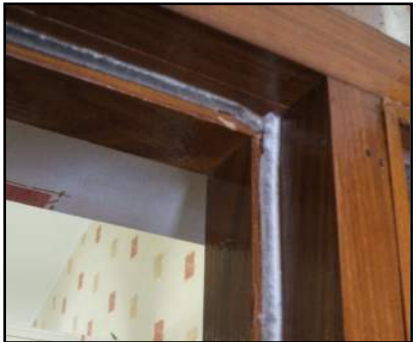
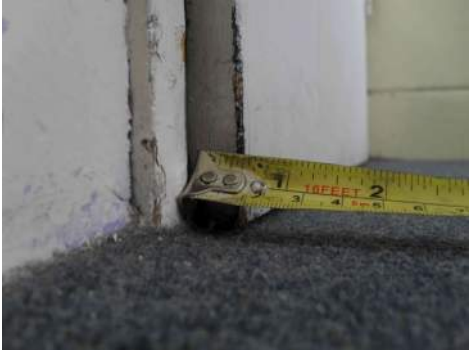
<p><b>Description of damage:</b> The door leaf/leaves are not closing fully resulting in the leaves being out of alignment.</p>		
<p><b>Repair Technique Option:</b></p> <p>When the door leaf/leaves are not closing fully, resulting in alignment of the leaf/leaves with adjacent elements (frame reveal in the case of single leaf doorsets or opposing leaf in the case of double leaf doorsets) being more than 1mm out of alignment, the following shall be investigated:</p> <ul style="list-style-type: none"> <li>○ Check that there is not an issue which is preventing the leaf from closing fully, such as incorrectly positioned or damaged hinges, seals, or door stops, etc.</li> </ul> <p>If an issue is identified, temporarily remove the offending component to see whether the door leaf closes correctly. If correct closing operation is now achieved, reposition, and secure the offending component, then check if the problem persists. If the issue has been determined to be caused by a damaged item of building hardware (e.g., hinges which have worn away) the item must be replaced on a like for like basis.</p> <p>If it is observed that the alignment issue is due to the installation of the doorset and there is no apparent damage to the leaf or frame, the doorset may be removed from the structure and reinstalled in accordance with the manufacturer's installation instructions. In the absence of supporting evidence BS 8214: 2016 may be referred to for timber doorsets up to 60 minutes fire resistance performance only.</p>

<p>Example of door leaves which are out of alignment.</p>	<p>Example of an incorrectly fitted smoke seal, which may cause misalignment of door leaves.</p>	<p>Example of a twisted door leaf which may require replacement if it cannot be relocated within the frame reveal.</p>

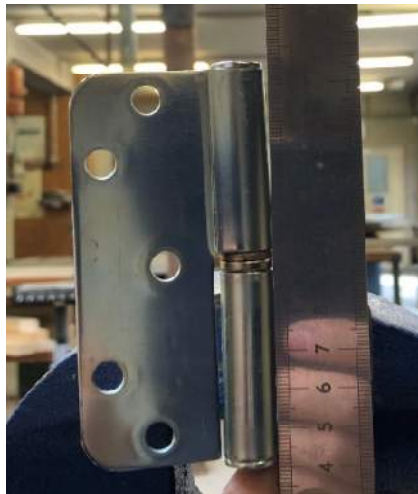
Example of a lift off type hinge where the pin has bent over time.

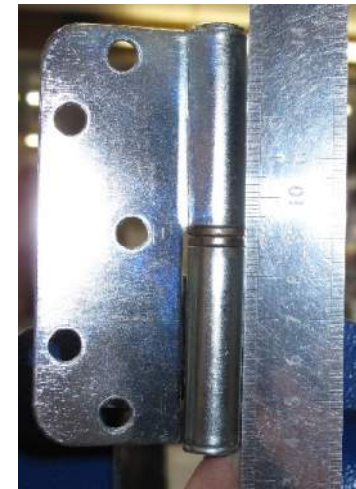
Example of a replacement identical hinge.

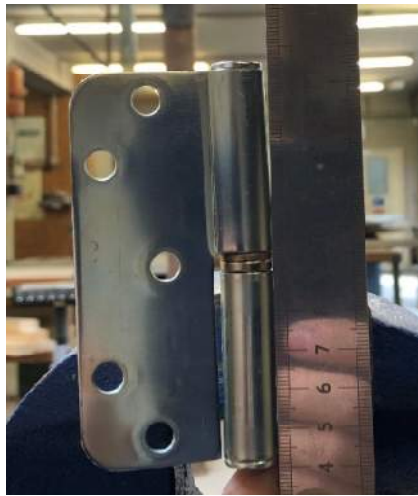
Example of a lift off type hinge where the pin has bent over time.

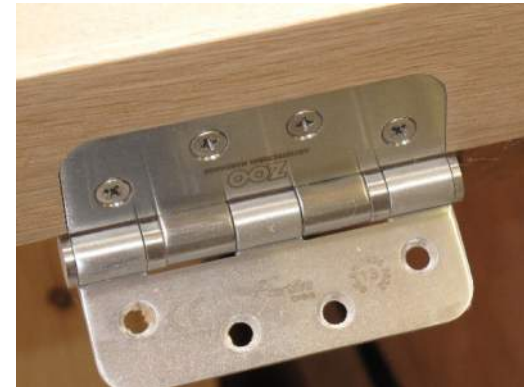
Example of an alternative hinge fitted in place of the previously removed damaged hinge.

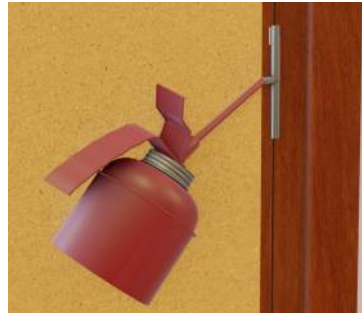
Example of lubrication of hinges.

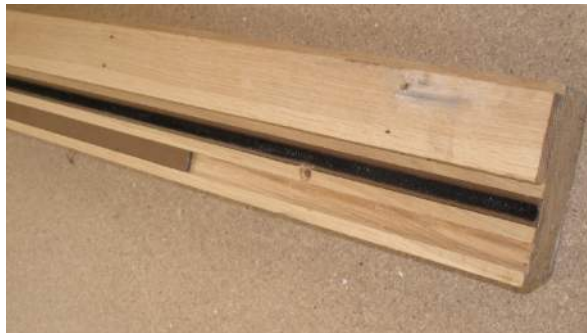
Example of damaged or missing seal.

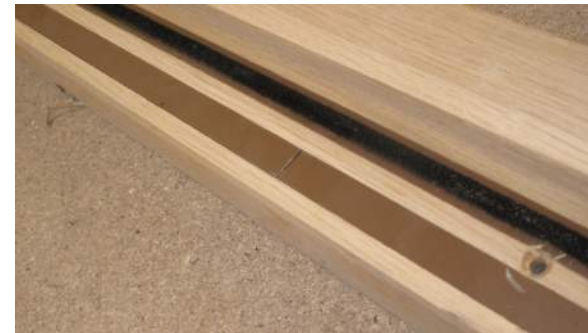
Example of replacement seal with tight butt joints.

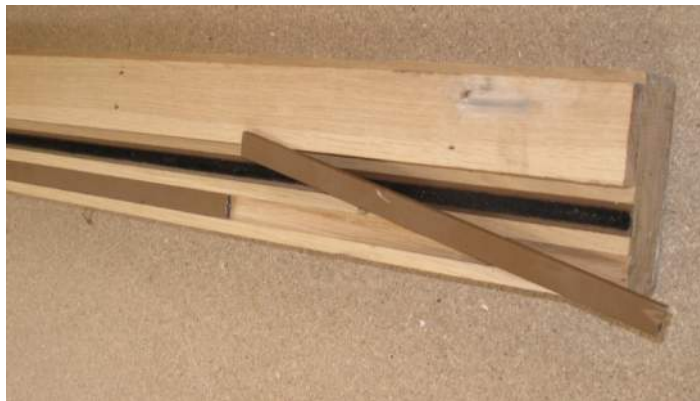
Example of seal falling away from groove

1. A replacement of the adhesive applied to the rear of the seal may be sought from the manufacturer of the seal. It is not possible to apply an alternative manufacturer's adhesive in this application, therefore, where the seal manufacturer is unable to supply the existing specification of adhesive strip, this option is not permitted.
2. Replacement of the entire length of intumescent seal as detailed within Repair Technique Option 1 above.
3. Where the seal manufacturer can supply test evidence for, or the doorset subject to repair includes pin fixing of the intumescent, it may be possible to apply pin fixings in line with the supplied evidence or existing specification. If the manufacturer does not have this evidence available, and existing pins are not present, pins must not be used to re-affix seals within their grooves.

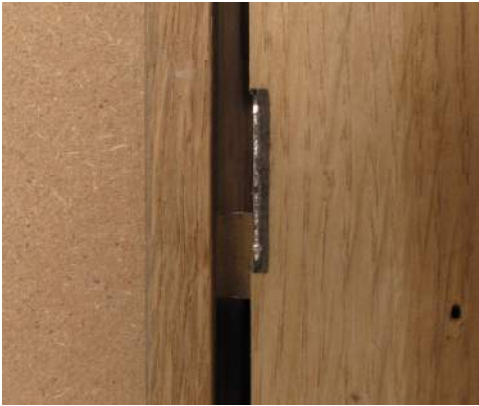
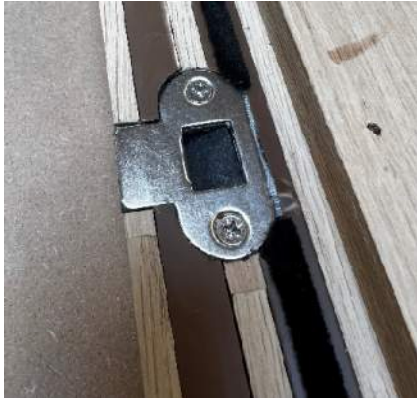
Example of misaligned latch keep.	Example of repositioned keep.

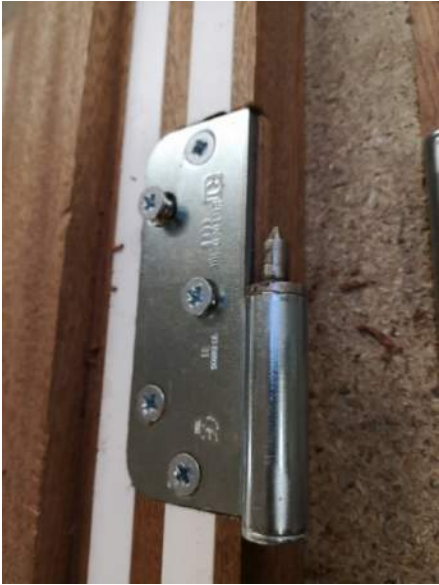
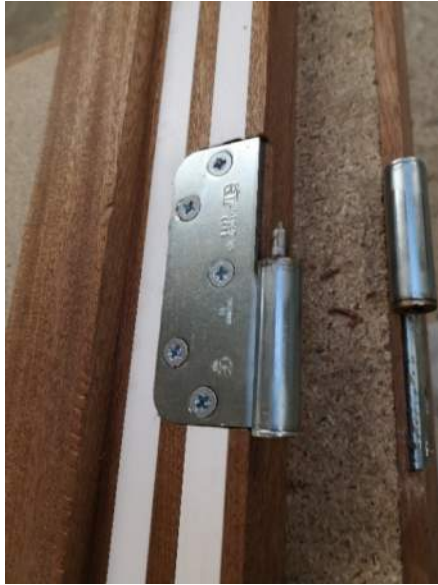
<p><b>Description of damage:</b> Door leaf has dropped due to loose hinge fixings. Check for issues that are potentially placing undue stress on the hinges and rectify as appropriate (e.g. obstruction between the door and frame)</p>	
<p><b>Repair Technique Option 1: (Tighten or replace screws)</b></p> <p>Initially tighten the existing screws which are in-situ. If the existing screws do not tighten to give appropriate fixity, replace the screw for an alternative steel-based wood screw with a larger diameter thread. Longer screws than the existing are permitted. If any screws are missing, source an alternative steel-based wood screw of the same dimensions as other present screws used as hinge fixings. If the new screw does not tighten, replace as detailed above. All screw positions on each hinge must be utilised.</p>

<p>Example of loose screw fixings.</p>	<p>Example of screws replaced and tightened.</p>

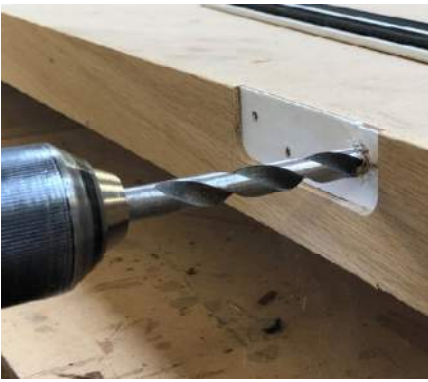
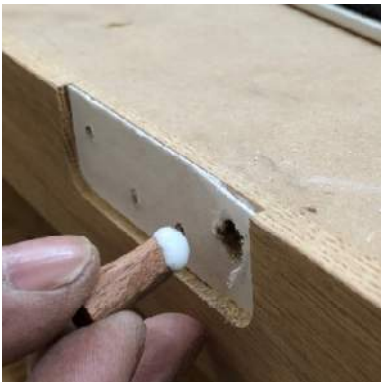
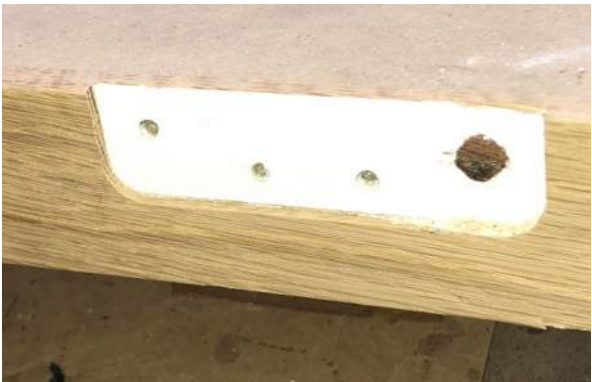
Repair Technique Option 2: (Fixing position)		
<p>If the leaf or frame can no longer act as an adequate fixing point at the existing screw locations, the damaged area can be drilled out to a maximum of Ø12mm diameter to the full depth of the frame and a maximum of 30mm depth within the leaf. The hole is to be plugged with a hardwood dowel, with a minimum density of 640kg/m<sup>3</sup>, which is to be glued in position with a urea formaldehyde-based adhesive. Once the plug has been fitted and the adhesive is allowed to cure, the fixings may be reapplied.</p>

Drilling out existing fixing position.	Example of hardwood plug being applied.	Hardwood plug applied and trimmed flush prior to reapplication of hinge.

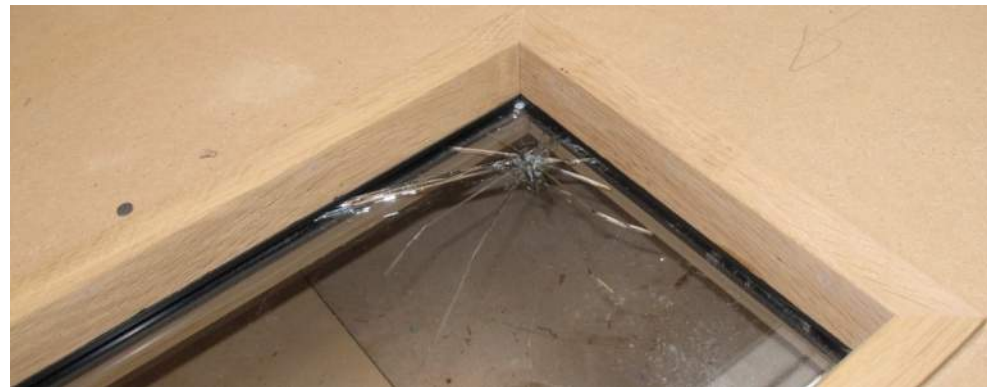
Example of broken glass

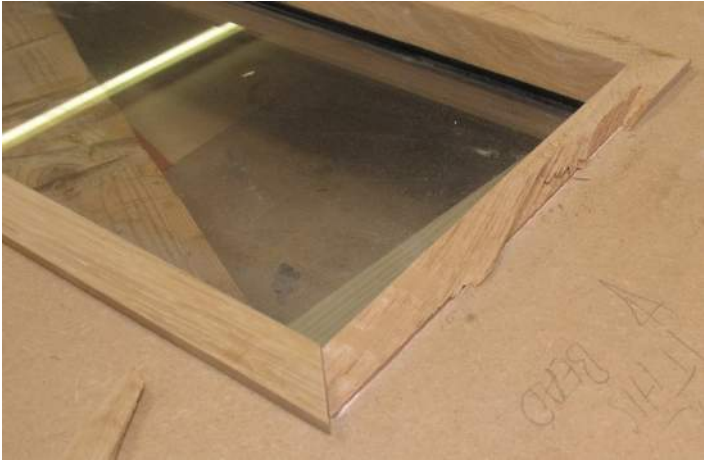
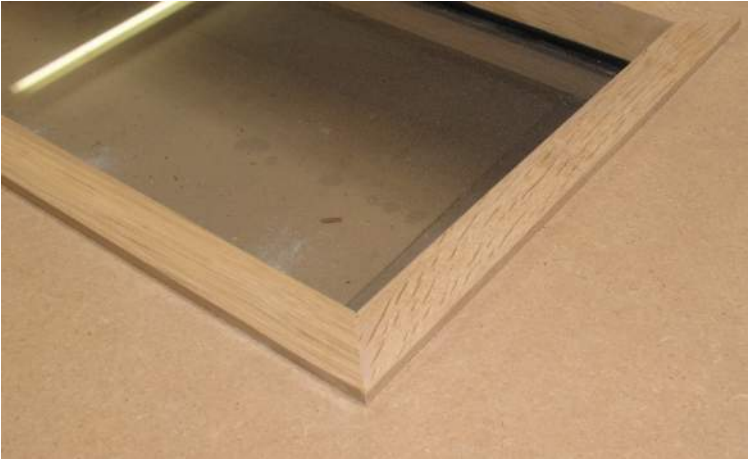
Repair Technique Option 2: (Damaged glazing beads)	
<p>If the glazing beads are damaged, the entire length of beading must be replaced with 'like for like' beading.            The replacement beading must match the existing glazing bead material, profile and density.            The glass may be retained providing it is not damaged on removal.            The same type of glazing seal must be used at the location of the replaced section of glazing bead. If this is not possible the entire glazed aperture must be re-glazed following Repair Technique Option 1.            The glazing bead fixing type and dimensions, fixing spacing, and angle at which the fixings are applied, are critical to the performance of glazing within door leaves. As such, these items must be replaced specifically in a 'like for like' manner.</p>

Example of damaged glazing bead.	Example of repaired glazing bead.

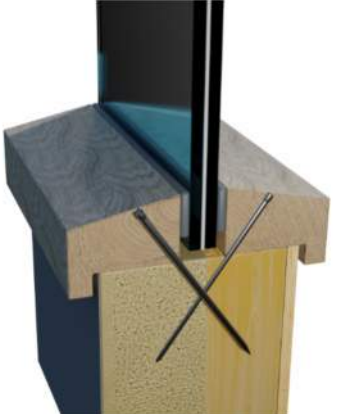
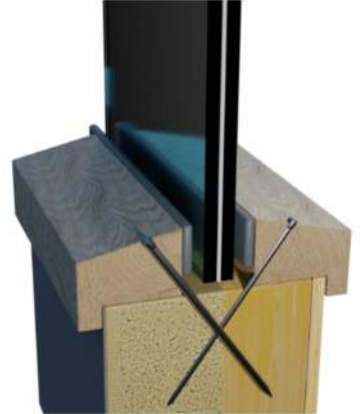
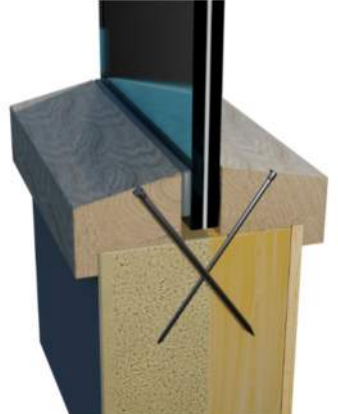
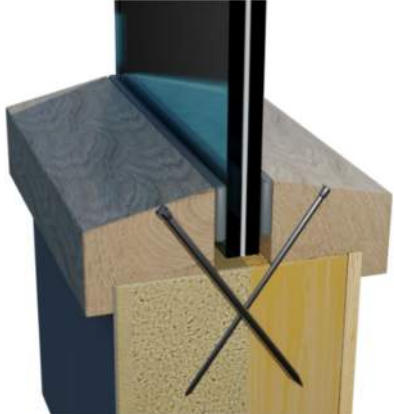
If the glazing system is poorly fitted or the glass is loose within the aperture the glass should be re-glazed accordingly, using the appropriate doorset manufacturer's specification. The glazing bead, glazing bead fixing type and dimensions, fixing spacing, and angle at which the fixings are applied, are critical to the performance of glazing within door leaves. As such, the doorset manufacturers tested or assessed detail shall be followed in all cases.

<p>Incorrect – Glazing bead overhanging door leaf.</p>	<p>Incorrect – Glazing bead too small leaving void between glazing system and glass.</p>	<p>Incorrect – Intumescent missing from one side of the glass.</p>	<p>Correctly installed glazing system.</p>

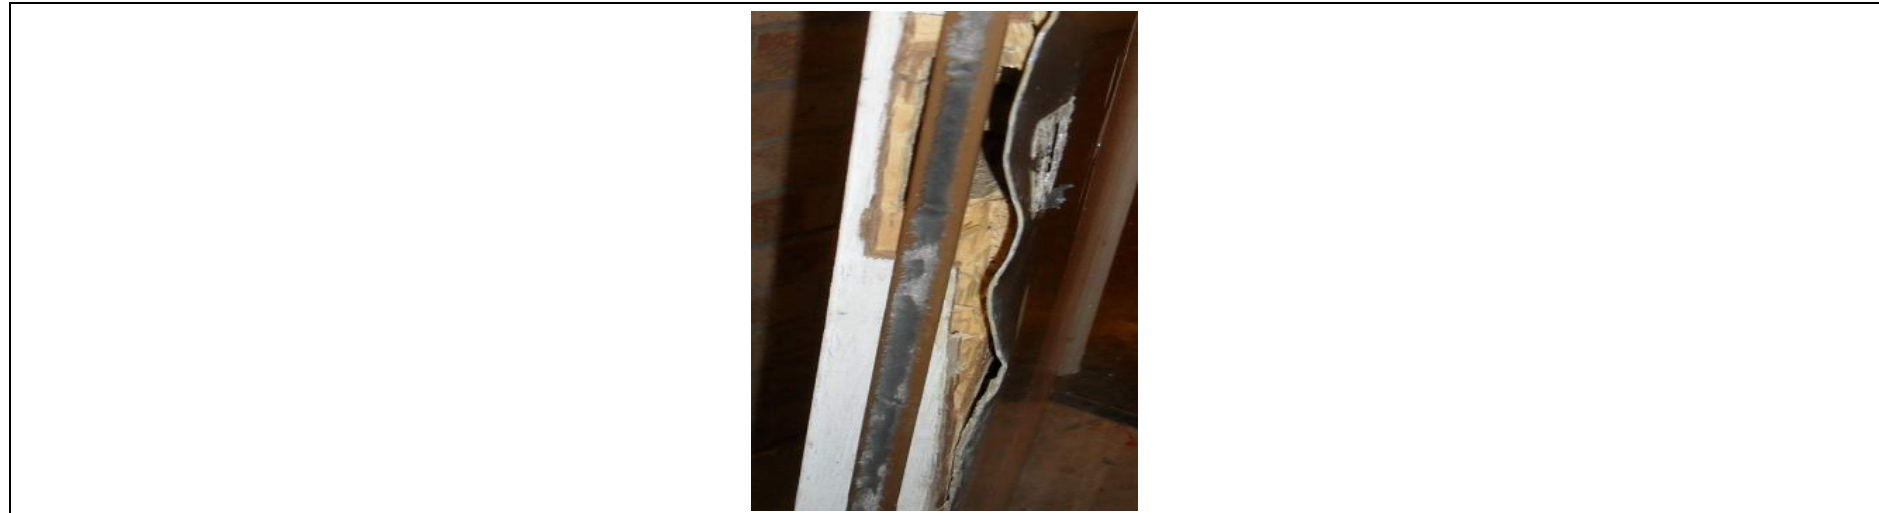
Example of a door leaf which requires replacing

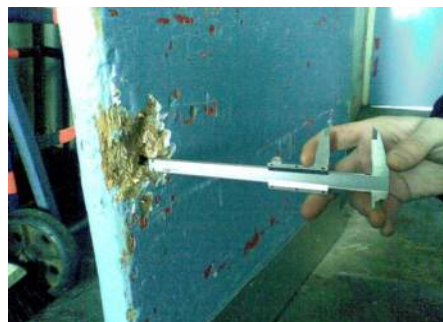
**Example of a doorset which requires replacing –** The damage on this doorset revealed a hollow core construction and was not therefore, deemed adequate for the required period of fire resistance. Furthermore, the door was recorded as 44mm thick, had a softwood door frame but was required to achieve a 60 minute fire resistance. The entire doorset was recommended for replacement.

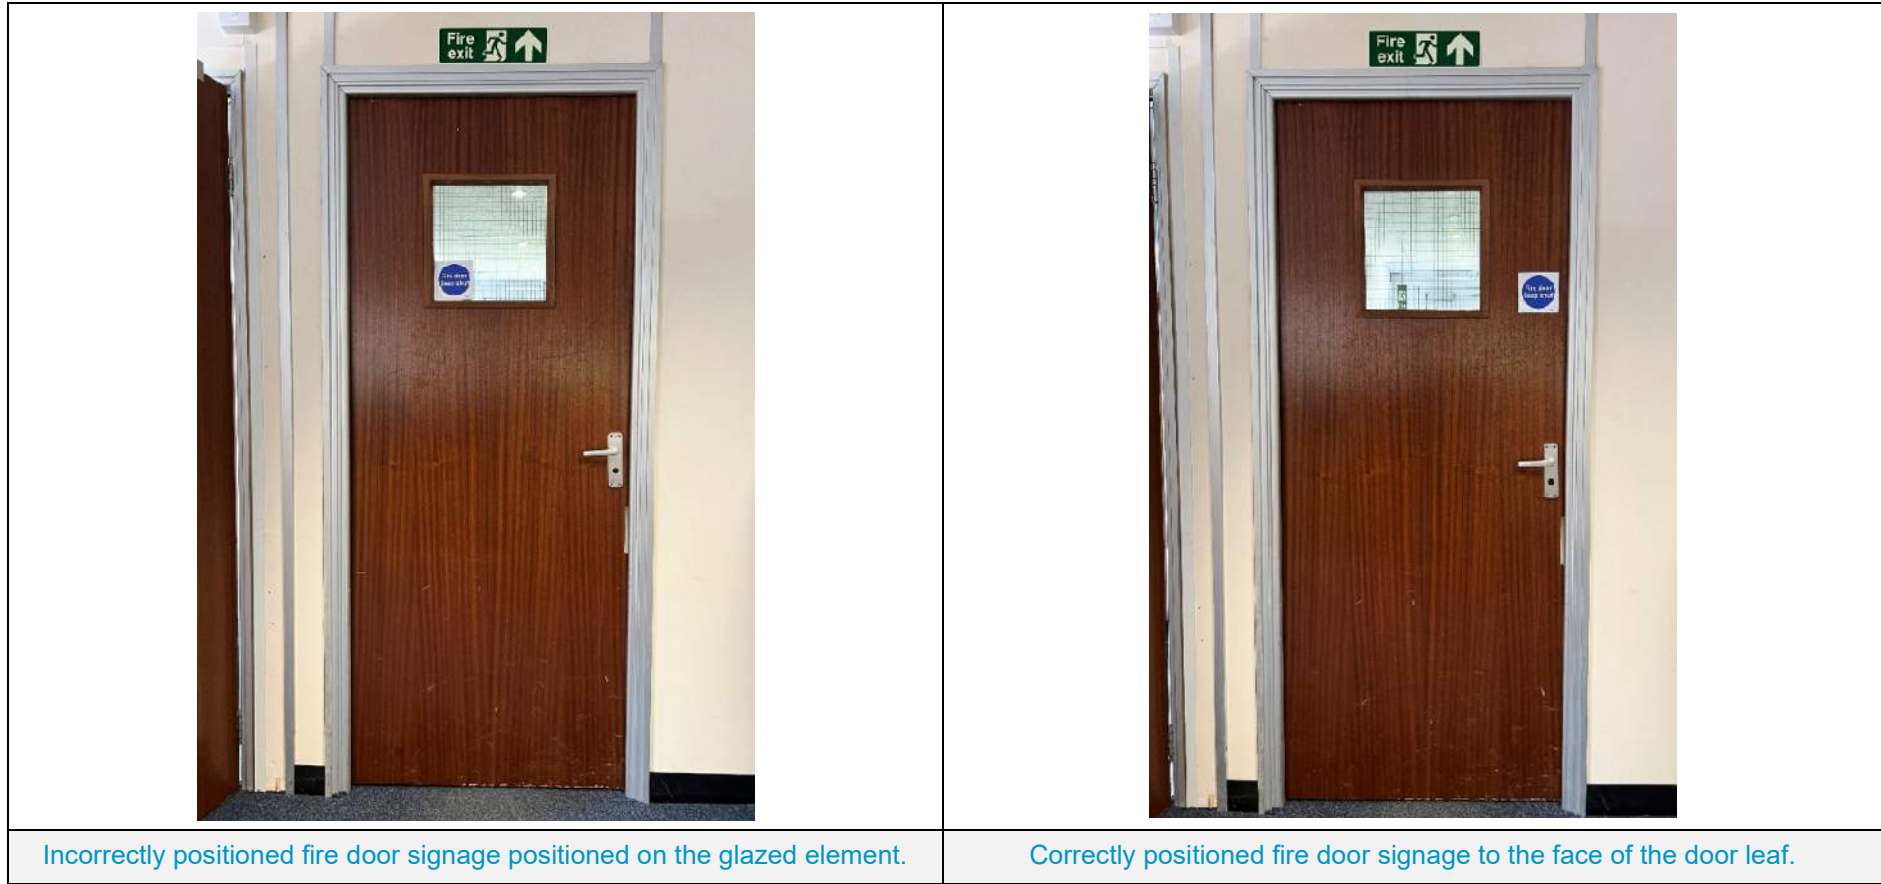
Incorrectly positioned fire door signage positioned on the glazed element.

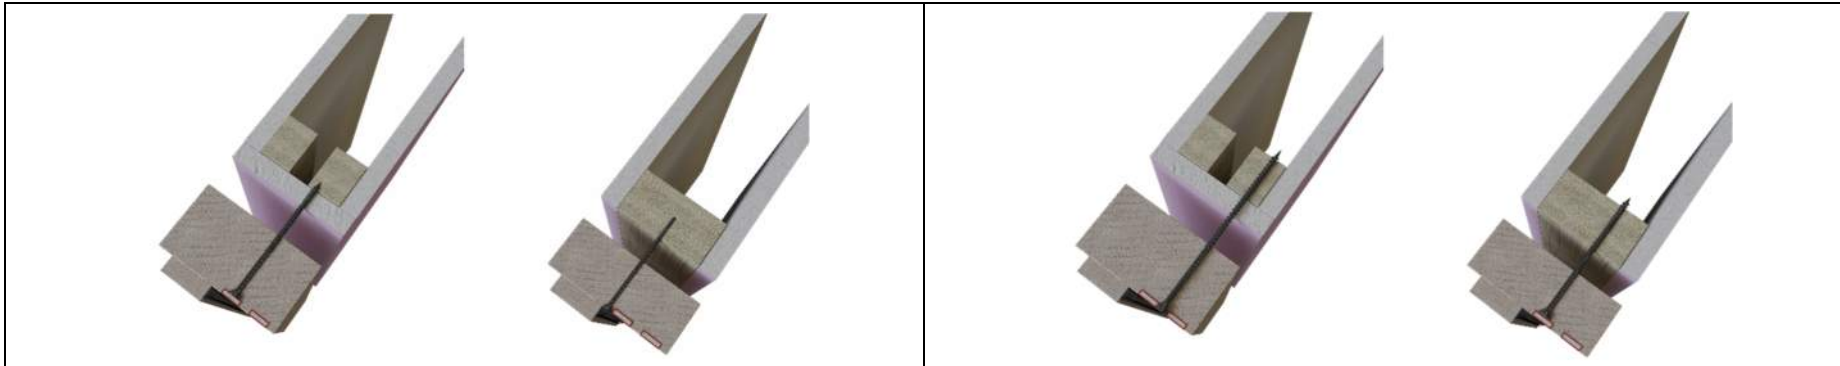
Ineffectual fixings which did not penetrate supporting structure sufficiently.
