# FIRE DOOR MAINTENANCE SCHEME

## Index of Accepted Repair Techniques

FIRE DOOR MAINTENANCE SCHEME	
Accepted Repair Techniques	
ART Number	01 Lipping Repair
Revision Number	10
Issue Date	01 January 2024
Expiry Date	31 December 2024

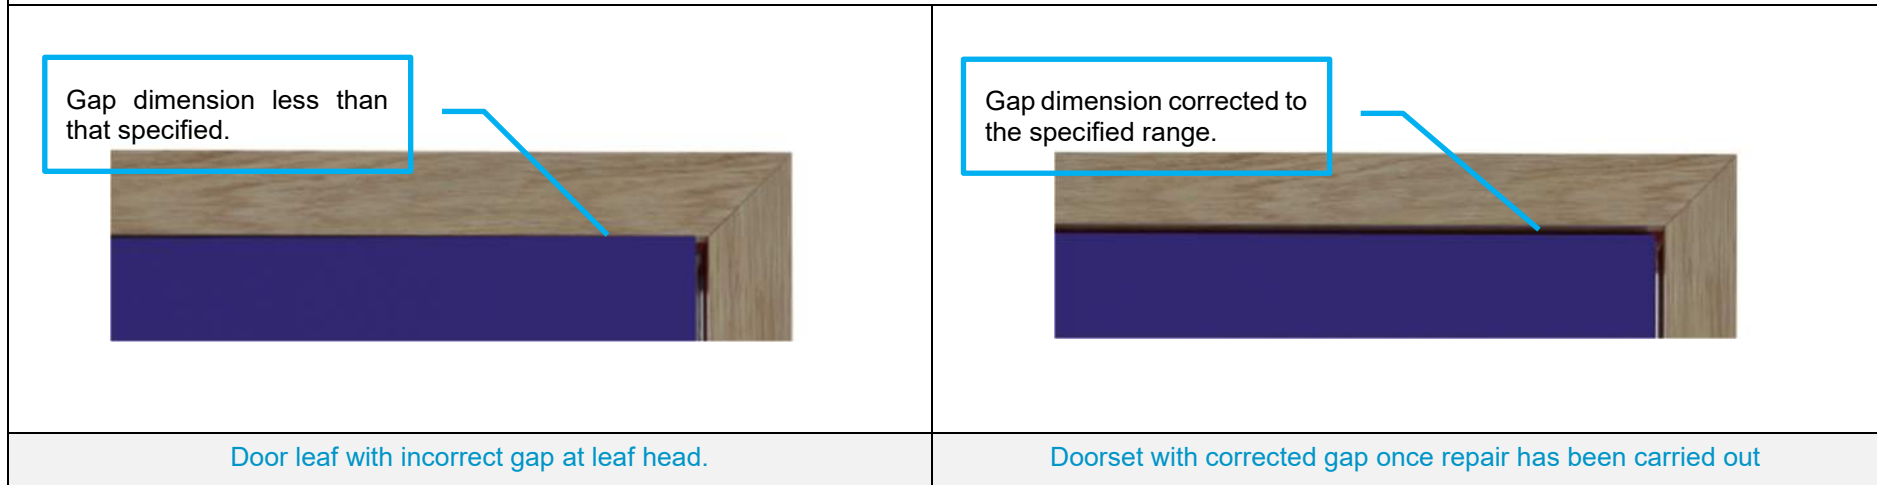
Where leaf to frame door gaps are outside of the tolerance permitted by the supporting evidence for the doorset design, the door gaps will require alteration. In some cases, it may be possible to achieve this by alteration of the packers applied behind the frame. This option is only applicable where specific manufacturers doorset fitting instructions are available and the adjustment must be completed as follows:

- If necessary, remove associated architrave to achieve access.
- Loosen the fixing local to where the packers require alteration.
- Adjust packers to suitable thickness to achieve desired leaf to frame gaps. Packer type should be in accordance with the doorset manufacturer’s instructions.
- Tighten frame fixing into position such that the frame clamps the modified packer against the supporting construction.
- Apply an approved fire stopping solution from the supporting evidence for the doorset design.

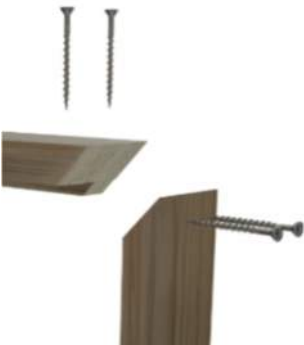
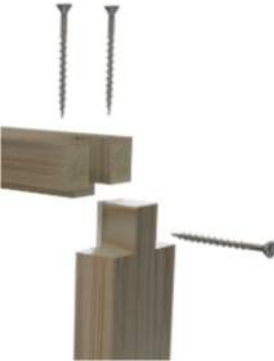
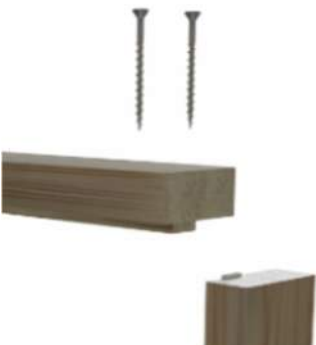
<div style="text-align: right; font-size: small;">BS 8214:2016</div>   <p style="text-align: center;"> <b>Timber-based fire door assemblies – Code of practice</b> </p>
Example of mortice and tenon joint.	Example of intumescent seal.	Example of plastic packing behind frame.	BS 8214:2016 Timber-based fire door assemblies – code of practice.

Half lapped joint.	Mitre joint.	Bridle joint.	Butt joint.

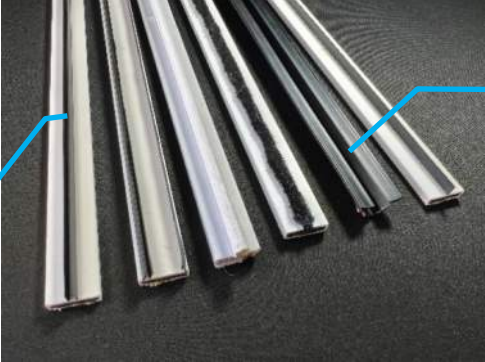
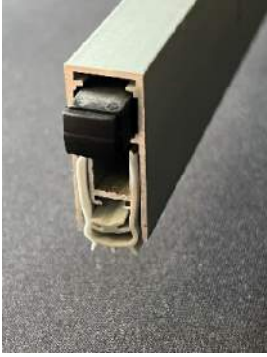
<div style="display: flex; align-items: center;"> <div style="border: 1px solid blue; padding: 5px; margin-right: 10px; width: 20%;">                 All other seals demonstrate combined intumescent and smoke seals.             </div>

<div style="border: 1px solid blue; padding: 5px; margin-left: 10px; width: 20%;">                 Example smoke only seal.             </div> </div>

Examples of combined intumescent and smoke seal and smoke only seals.	Example of drop-down seal.

**Repair Technique Option 2: (Adjustment or replacement of a drop-down seal)**
